LAKE HAVASU CITY, ARIZONA

ADDENDUM NO. 2

Lake Havasu City Police Department Rehabilitation Project PROJECT NO. 103006

November 9, 2023

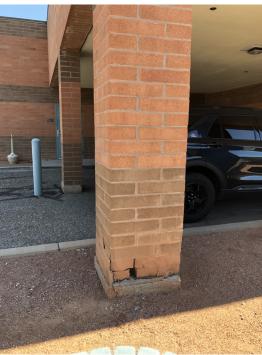
Masonry, if not constructed to be resistant to corrosive soils, may leach corrosive chemicals from the soils up from the ground and can cause deterioration of the masonry blocks. It is common to see the lower halves of walls deteriorate before the upper halves. Lack of grout may allow water intrusion inside the masonry cells and could potentially exacerbate the corrosion and deterioration of the masonry.

Photo 1: Front Face Exterior Deteriorated Column

The structural retrofit for the columns from Photos 1-3 and 8 is shown in Figure 2 below. Where the exterior sidewalk is cracked in locations such as that in Photo 8, cut and remove the sidewalk square containing the cracked-off piece. Drill & epoxy #4x18" bars into the center of the existing concrete slab at 18-inches on center with Simpson Set-3G at new-to-existing slab locations.

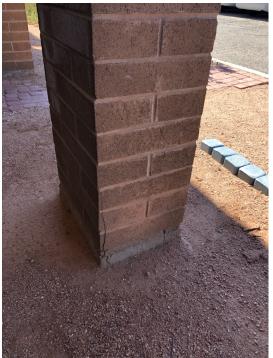
Photo 2: Rear faces of exterior deteriorated column

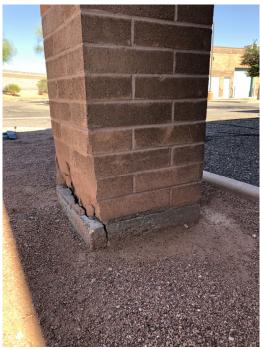
Photo 3: Close-up of exterior deteriorated column

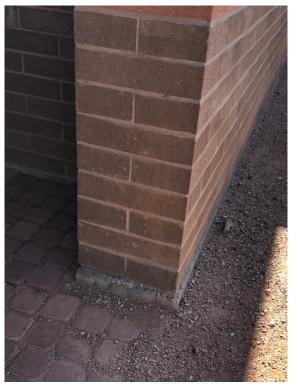
Photo 4: Masonry spalls at wall

Our recommendation for the wall spalls is to use a stiff wire brush to remove any loose debris and then apply a high-quality mortar such as Sikadur-35 Hi-Mod LV or equivalent to the spalls and cracks and ensuring the mortar penetrates the full depth of the CMU shell. A low-viscosity mortar may help to ensure there is adequate penetration into the CMU. The testing agency mentioned previously should apply a crack measuring system to determine if the spalls continue to grow over time after applying the mortar.

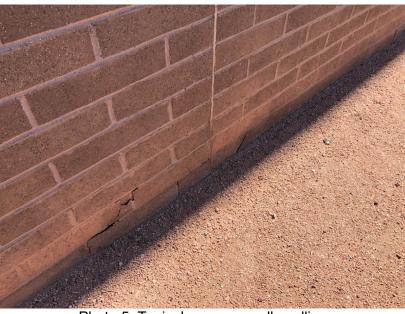
Photo 5: Typical masonry wall spalling

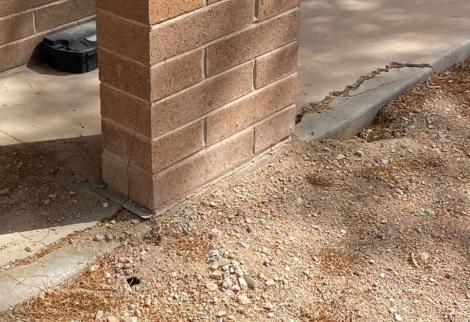
Photo 8: Close-up of column cracking

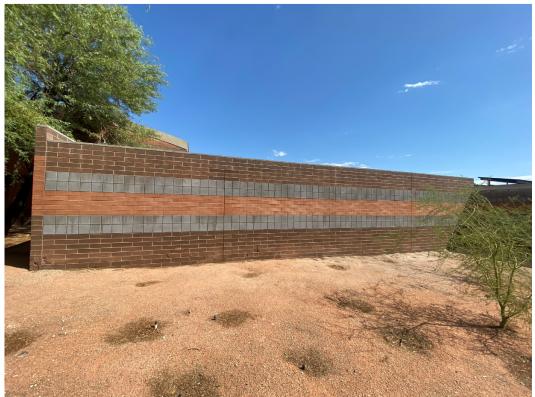
Photo 9: Site wall foundation deterioration

Our recommendation for the site wall shown in Figure 9 is to retrofit using the aforementioned mortar and wire brush, or per the structure owner option remove and replace may be desirable.
